# Engineering-Geological Evaluation of Salaito Road, Santiago de Cuba

**Abstract:** The geotechnical deterioration causes of Salaito Road are evaluated in this study. That roadway provides access to Cementos Moncada S.A. factory in Santiago de Cuba and is subjected to heavy traffic loads. A review of the state of the art on road deterioration was conducted, along with a specific analysis of the road, including the physical and mechanical properties of the base and subbase soils. Five main lithologies were identified as contributors to problems such as subsidence and cracking, manifested on the asphalt layer as crocodile skin cracking, subsidence, longitudinal and cross cracks, and rutting. The findings provide a strong basis to carry out corrective measures and enhancements to the design and maintenance of road infrastructure.

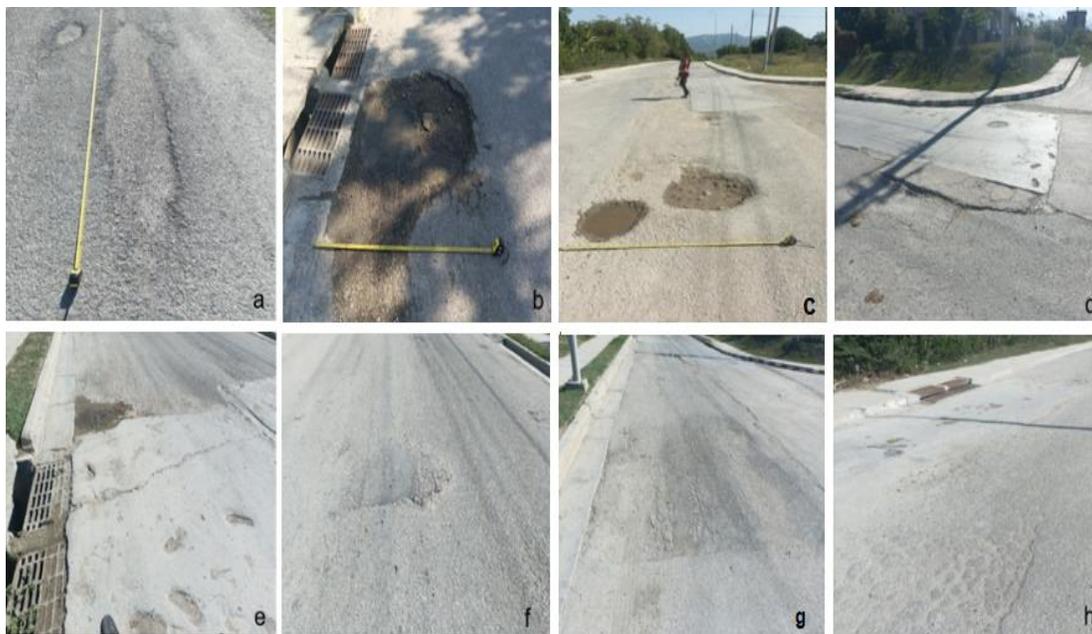
The geological survey revealed that the main damages observed on the road corresponded to potholes, longitudinal and cross cracks, patching works, subsidence, aggregate stripping, rutting, crocodile skin cracking, bumps, cracking, and exudation (Figures 2 and 3). Most of these deficiencies were found in areas where water and sewer works had been installed after the construction of the road's technified embankment, which compromised the strength of the embankment and its ability to deal with water in those areas.

Figure 2. a), b), c) Potholes. d) Patching, subsidence s. e) Patching, pothole and cross crack in concrete slab. f) Concrete pouring on the roadway, aggregate stripping. g) Cross cracks, concrete patch and subsidence. h) Crocodile skin cracking and patching.

The deterioration of Salaito road is the result of a combination of inadequate materials, alterations in the embankment's compaction, and the constant presence of water within it.

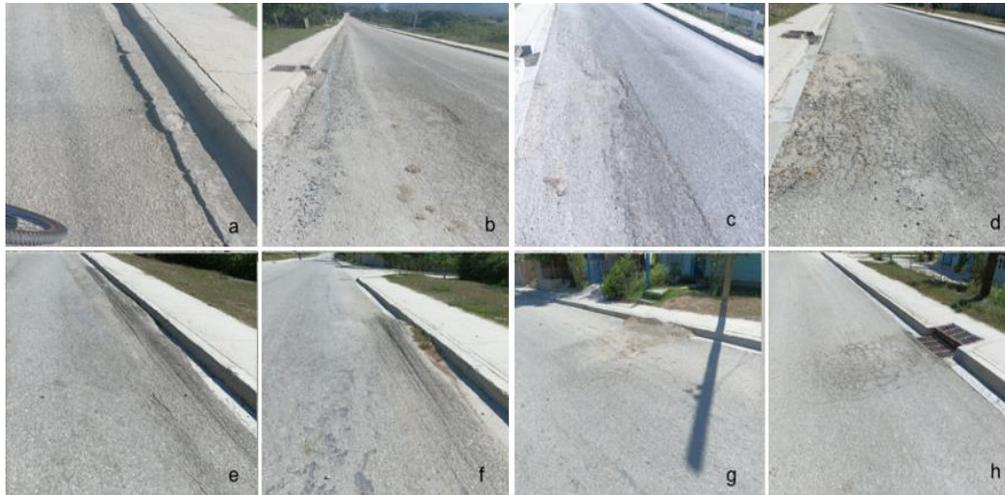
Figure 3. a) Subsidence. b) Concrete pouring on the roadway, aggregate stripping and potholes. c) Aggregate stripping. d) Crocodile skin cracking. e) Bump, subsidence and rutting. f) Bumping, subsidence, rutting and exudation. g) Bumping and subsidence. h) Block cracking.
