Assessment of the Remaining Life of Liquefied Petroleum Gas Pressure Vessels Located in Coastal Areas

Therefore, this work is aimed at determining the corrosion rate and evaluate the remaining life of vessel number 4 from the LPG battery at Hotel Brisas Guardalavaca (Holguín, Cuba), through inspection following the API 510 (2022) standard.

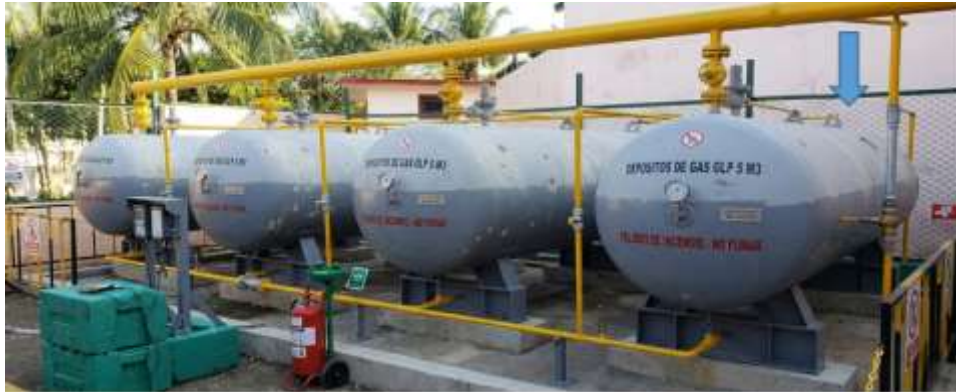
Vessels 1, 2 and 3 were replaced in 2024; at the time of inspection, they showed no evident damage. Vessel 4 has been in operation since the hotel was built.

Figure 1. General view of LPG vessel battery at Hotel Brisas Guardalavaca, indicating vessel 4 position.

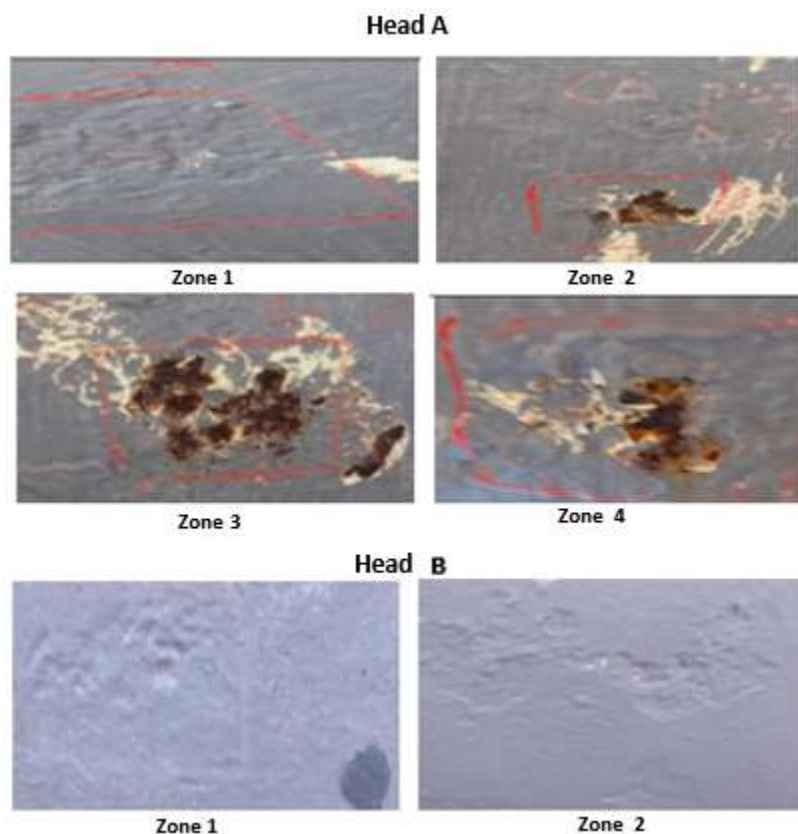
From the inspections performed, damage was identified on the external part of the vessel, on the cylindrical shell, the base, the lower part of the shell, the upper part and the heads. Table 2 shows the affectations on the heads (high dispersion zones). Figure 4 shows the areas affected by corrosion on heads A and B of vessel 4, where specific areas (Zones 1-4) with pitting on the external surface are identified; these were later on selected for a detailed measurement of thicknesses and pit depths.

Figure 4. Evidence of damage on the vessel heads.

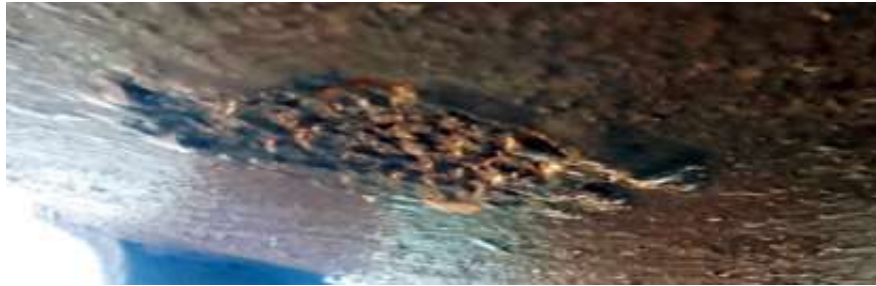
The type of damage identified was pitting corrosion (Figure 5). Pits of different morphology and size are observed, which concentrate material loss at specific points

and comprise the critical zones considered in the corrosion rate and remaining life analysis.

Figure 5. Area affected by pitting corrosion (lower part of the vessel).

Maintenance: to apply local repair by welding on >2 mm-depth pits or epoxy coating in areas with <2 years remaining life, according to API 510.

Withdrawal: to preventively withdraw vessel 4 from service, replacing it with a new or workshop-repaired unit, given its critical remaining life of 1 year and the risk of propagation in the battery.

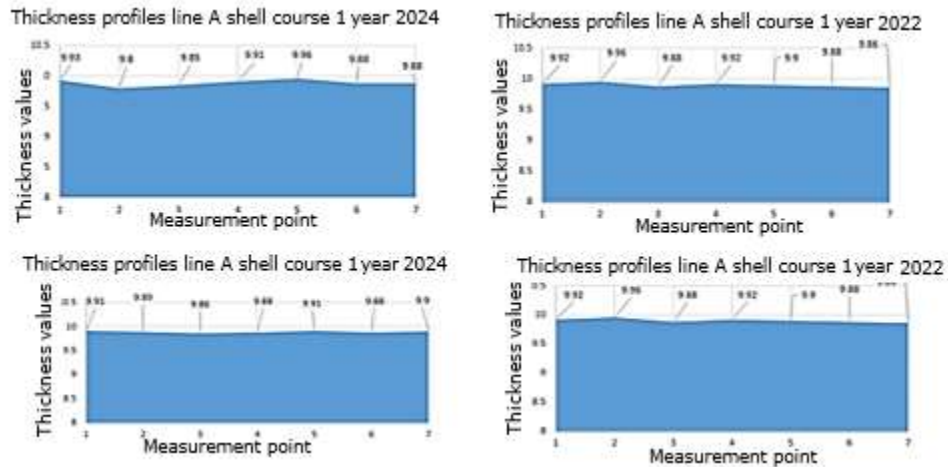
From the thickness values taken by ultrasound, thickness profiles in the form of a cross-section cut of the vessel wall were obtained. Figure 6 shows the thickness profiles measured by ultrasound on the different elements of vessel 4 (heads and shell courses), representing the minimum values recorded between 2022 and 2024 along the cross-section of the wall, showing the thickness loss spatial distribution on the external surface.

Figure 6. Thickness profiles measured by ultrasound.
