Evaluation of corrosion in metallic pipelines caused by petroleum derivatives. Case study: Angolan Distributor

Evaluación de la corrosión en ductos metálicos por derivados del petróleo. Estudio de caso: Distribuidora angolana

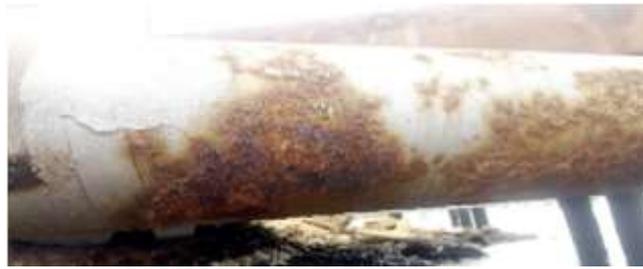
Figure 1. Corroded pipeline.

Direct observation of the facilities allowed identifying the areas most affected by corrosion, such as pipelines exposed to the marine atmosphere and storage tanks. Images and notes on the structures condition were recorded, enabling a qualitative analysis on the corrosion impact.

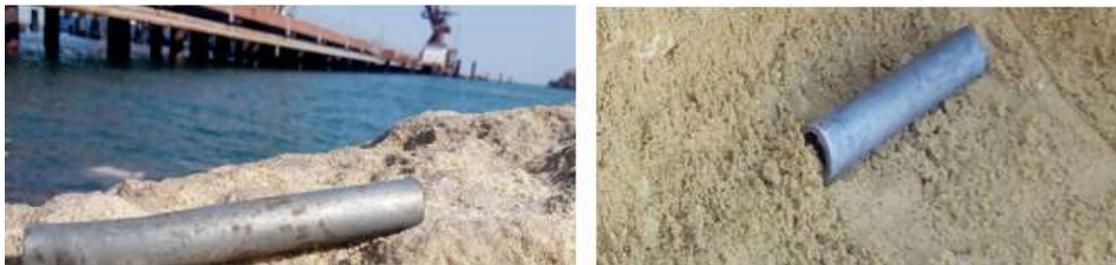
Figure 3. Sample a) exposed on the surface. b) when buried.

Samples from metal tubes with physicochemical properties similar to those of the pipelines used in the company were collected. These samples were exposed to different environmental conditions: one was buried at a one-meter depth and another remained exposed on the surface, simulating the corrosive environments found in the study area. The samples were monitored during 60 days, and changes on their surfaces were documented through photographs and laboratory analysis.

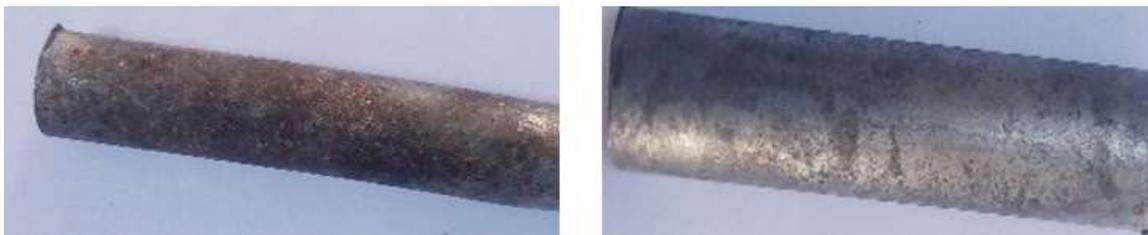
Figure 4. Oxidation degree of the sample. a) Sample A. b) Sample B.

Metal pipe samples exposed to different environmental conditions showed different behaviors regarding corrosion. The sample exposed on the surface (sample A) showed a significantly higher degree of corrosion than the buried sample (sample B). This difference is a consequence of the marine environment, characterized by a high relative humidity, the presence of dissolved salts in the air and water, and direct exposure to sea spray, factors that accelerate the corrosion of carbon steel. The buried sample (sample B), although in contact with soil moisture, was not directly exposed to airborne salts or marine spray, thus presenting a lower corrosion rate. This evidences that the intensity of external corrosion is directly related to exposure to the aggressive marine environment.

Visual inspection and laboratory analysis indicated that sample A presented uniform corrosion (Grade A according to ISO 8501-1), with oxide formation and material loss, while sample B showed minimal signs of corrosion. This confirms that the subsoil corrosiveness is less aggressive than the surface's in marine environments. That is because the subsoil, in spite of having moisture and ions responsible for corrosion, the oxygen and aggressive salts concentration is limited, therefore reducing carbon steel oxidation rate. In contrast, the surface in marine environments is constantly exposed to oxygen, high humidity, and salts dissolved in the air and water, factors that accelerate and intensify corrosion.

Visual inspection and laboratory analysis showed that sample A displayed uniform corrosion, classified as Grade A according to ISO 8501-1, with oxide formation and material loss on the surface. In contrast, sample B showed minimal signs of corrosion, confirming that the subsoil, although corrosive, is less aggressive than the surface in marine environments. Even though the subsoil is humid and contains corrosive ions, oxygen and aggressive salts availability is lower than in marine surfaces, which reduces carbon steel oxidation rate. These results are consistent with studies such as those by Ramos-Gómez *et al.* (2019), which underline the importance of proper anode selection to maximize cathodic protection efficiency.
