## Evaluation of corrosion in metallic pipelines caused by petroleum derivatives. Case study: Angolan Distributor

### Evaluación de la corrosión en ductos metálicos por derivados del petróleo. Estudio de caso: Distribuidora angolana

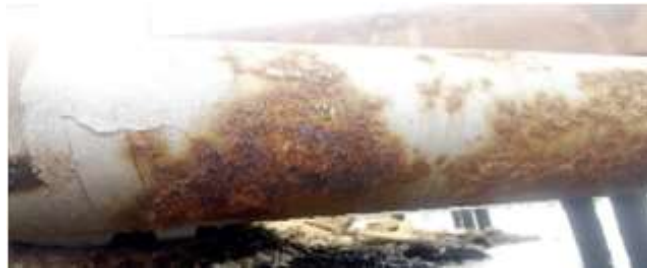
Figure 1. Corroded pipeline.

Direct observation of the facilities allowed identifying the areas most affected by corrosion, such as pipelines exposed to the marine atmosphere and storage tanks. Images and notes on the structures condition were recorded, enabling a qualitative analysis on the corrosion impact.

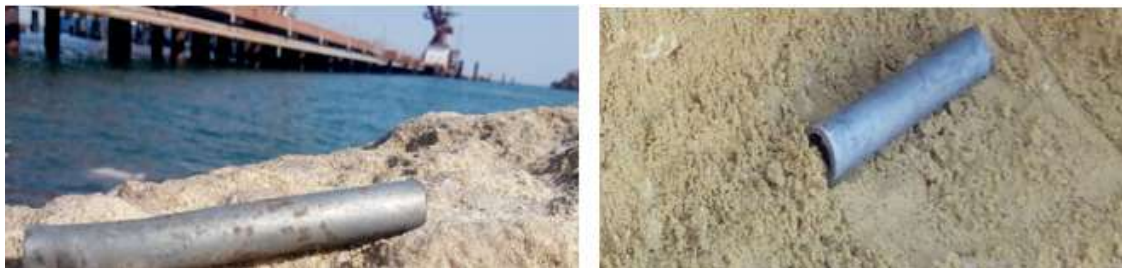
Figure 3. Sample a) exposed on the surface. b) when buried.

Samples from metal tubes with physicochemical properties similar to those of the pipelines used in the company were collected. These samples were exposed to different environmental conditions: one was buried at a one-meter depth and another remained exposed on the surface, simulating the corrosive environments found in the study area. The samples were monitored during 60 days, and changes on their surfaces were documented through photographs and laboratory analysis.

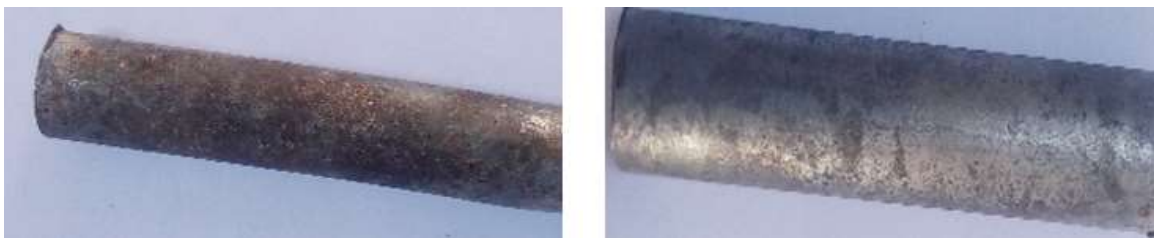
Figure 4. Oxidation degree of the sample. a) Sample A. b) Sample B.

Metal pipe samples exposed to different environmental conditions showed different behaviors regarding corrosion. The sample exposed on the surface (sample A) showed a significantly higher degree of corrosion than the buried sample (sample B). This difference is a consequence of the marine environment, characterized by a high relative humidity, the presence of dissolved salts in the air and water, and direct exposure to sea spray, factors that accelerate the corrosion of carbon steel. The buried sample (sample B), although in contact with soil moisture, was not directly exposed to airborne salts or marine spray, thus presenting a lower corrosion rate. This evidences that the intensity of external corrosion is directly related to exposure to the aggressive marine environment.

Visual inspection and laboratory analysis indicated that sample A presented uniform corrosion (Grade A according to ISO 8501-1), with oxide formation and material loss, while sample B showed minimal signs of corrosion. This confirms that the subsoil corrosiveness is less aggressive than the surface's in marine environments. That is because the subsoil, in spite of having moisture and ions responsible for corrosion, the oxygen and aggressive salts concentration is limited, therefore reducing carbon steel oxidation rate. In contrast, the surface in marine environments is constantly exposed to oxygen, high humidity, and salts dissolved in the air and water, factors that accelerate and intensify corrosion.
