## Evaluation of corrosion in metallic pipelines caused by petroleum derivatives. Case study: Angolan Distributor

### Evaluación de la corrosión en ductos metálicos por derivados del petróleo. Estudio de caso: Distribuidora angolana

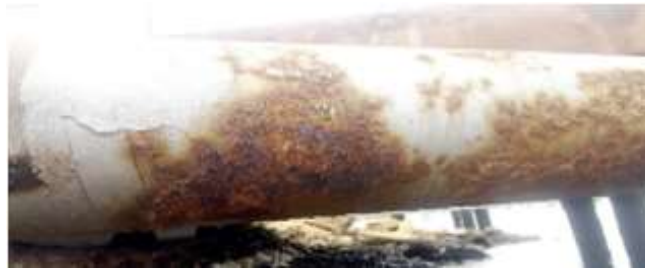
Direct observation of the facilities allowed identifying the areas most affected by corrosion, such as pipelines exposed to the marine atmosphere and storage tanks. Images and notes on the structures condition were recorded, enabling a qualitative analysis on the corrosion impact.

Figure 1. Corroded pipeline.

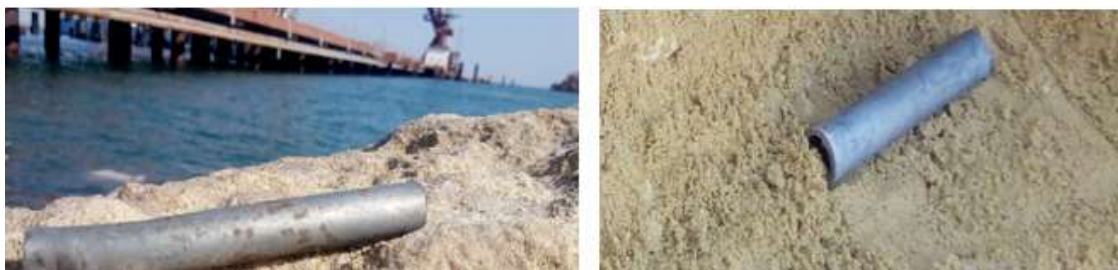
Samples from metal tubes with physicochemical properties similar to those of the pipelines used in the company were collected. These samples were exposed to different environmental conditions: one was buried at a one-meter depth and another remained exposed on the surface, simulating the corrosive environments found in the study area. The samples were monitored during 60 days, and changes on their surfaces were documented through photographs and laboratory analysis.

Figure 3. Sample a) exposed on the surface. b) when buried.

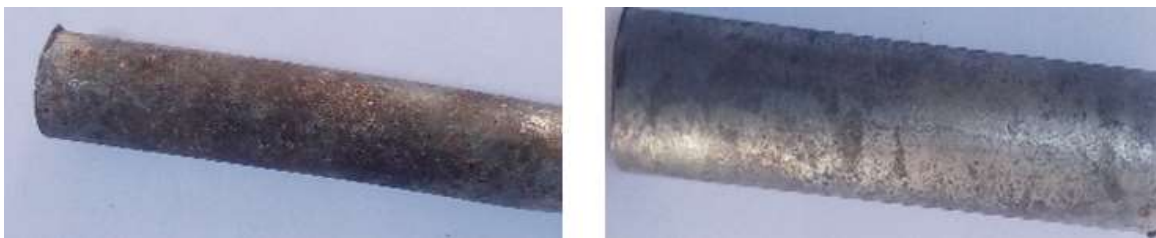
Metal pipe samples exposed to different environmental conditions showed different behaviors regarding corrosion. The sample exposed on the surface (sample A) showed a significantly higher degree of corrosion than the buried sample (sample B). This difference is a consequence of the marine environment, characterized by a high relative humidity, the presence of dissolved salts in the air and water, and direct exposure to sea spray, factors that accelerate the corrosion of carbon steel. The buried sample (sample B), although in contact with soil moisture, was not directly exposed to airborne salts or marine spray, thus presenting a lower corrosion rate. This evidences that the intensity of external corrosion is directly related to exposure to the aggressive marine environment.

Figure 4. Oxidation degree of the sample. a) Sample A. b) Sample B.

Visual inspection and laboratory analysis indicated that sample A presented uniform corrosion (Grade A according to ISO 8501-1), with oxide formation and material loss, while sample B showed minimal signs of corrosion. This confirms that the subsoil corrosiveness is less aggressive than the surface's in marine environments. That is because the subsoil, in spite of having moisture and ions responsible for corrosion, the oxygen and aggressive salts concentration is limited, therefore reducing carbon steel oxidation rate. In contrast, the surface in marine environments is constantly exposed to oxygen, high humidity, and salts dissolved in the air and water, factors that accelerate and intensify corrosion.
