Assessment of the Remaining Life of Liquefied Petroleum Gas Pressure Vessels Located in Coastal Areas

Therefore, this work is aimed at determining the corrosion rate and evaluate the remaining life of vessel number 4 from the LPG battery at Hotel Brisas Guardalavaca (Holguín, Cuba), through inspection following the API 510 (2022) standard.

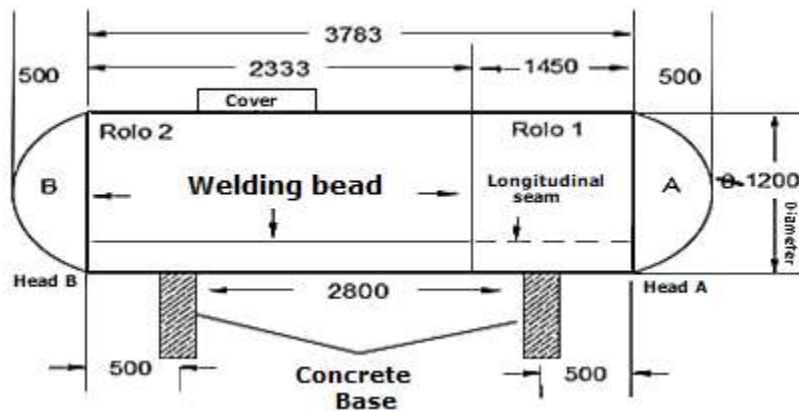
The object of study was vessel number 4 (5 m³, SA516Gr70 steel), built at Quintín Banderas factory, which is located in the Plaza de la Revolución municipality, in Havana city. The prevailing criterion in the vessel selection was: existing damage on the external surface (Figure 2).

Figure 2. Design characteristics of vessel 4 from LPG battery at Hotel Brisas Guardalavaca.

Figure 2 shows LPG vessel 4 diagram indicating its main geometric dimensions (diameter, cylindrical shell length, head geometry). The most relevant design data (operating pressure, test pressure and manufacturing material) provided by the manufacturer's nameplate are shown in Table 1.

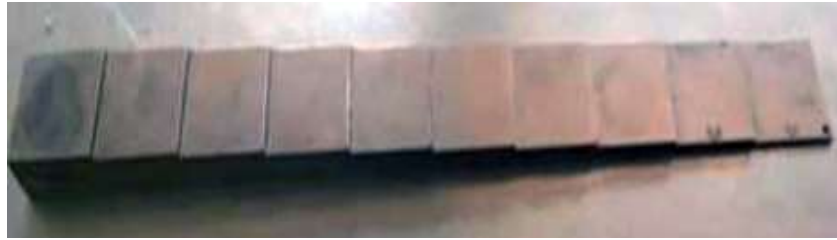
The equipment was adjusted using a step wedge from 1 to 10 mm with 1-mm steps as shown in Figure 3.

Figure 3. Step wedge from 1 to 10 mm with 1 mm steps.
